PROPERTY INSPECTION REPORT

123 Apple Ln.

Example, WA, 12345

Wednesday, May 9, 2018

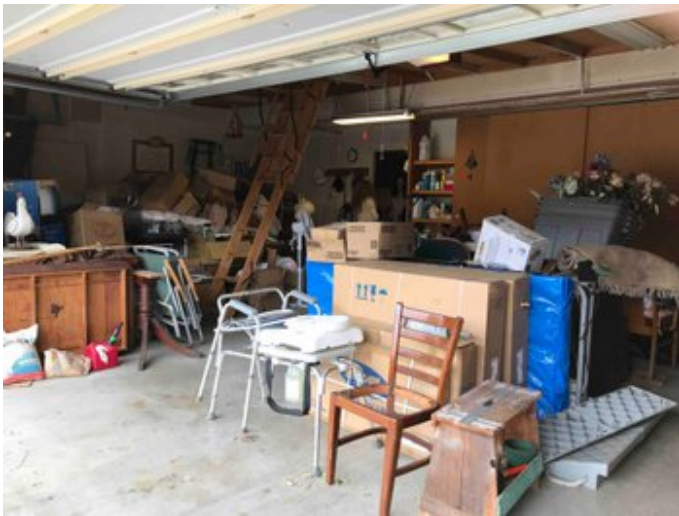
GARAGE OBSERVATIONS

The garage is too full of personal belongings for an adequate evaluation of the systems and components within. Therefore, it is important that you do a thorough investigation at some point after the garage has been emptied to determine if any addition deficiencies exists that were not visible at the time of the inspection.

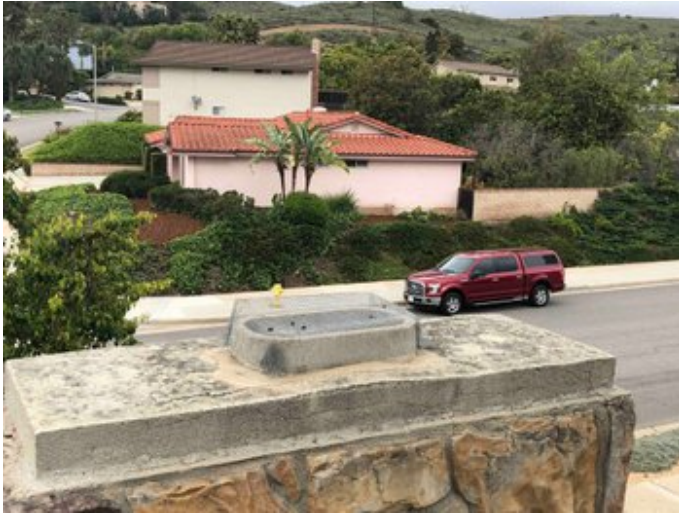
WEATHER CAP-SPARK ARRESTOR

The chimney has a spark arrestor but not a weather cap, which is recommended.

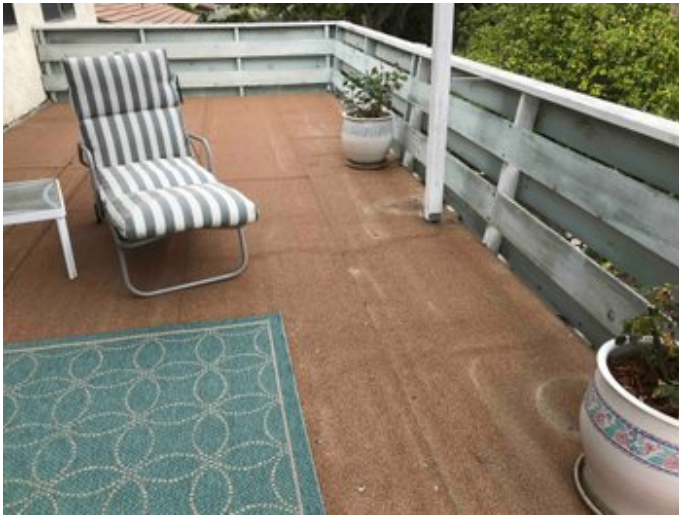
BALCONIES GUARDRAILS ETC

The balcony surface is sheathed with a mineral cap sheet, or a rolled-roofing material, which is not designed for foot traffic and should not be used as such or expected to last as long as a conventional balcony surface.

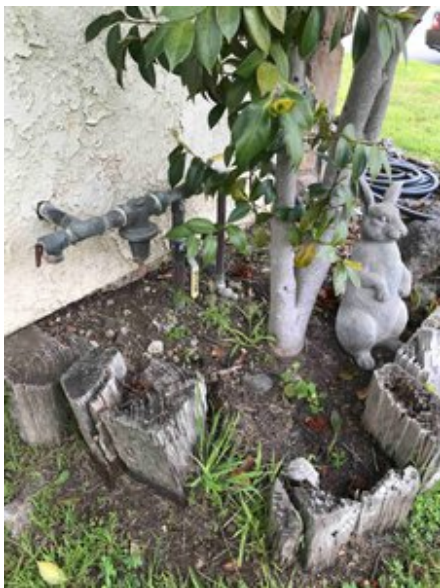
○ WATER MAIN SHUT-OFF LOCATION

The main water shut-off valve is located in the house side yard.

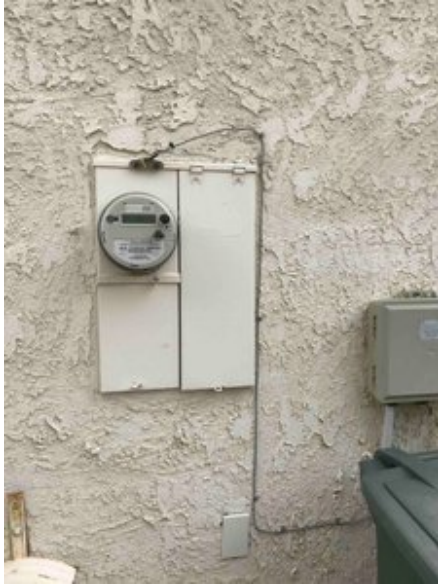
⬢ SERVICE PANEL SIZE & LOCATION

The residence is served by a 100 amp, 240 volt panel, located in the garage side yard.

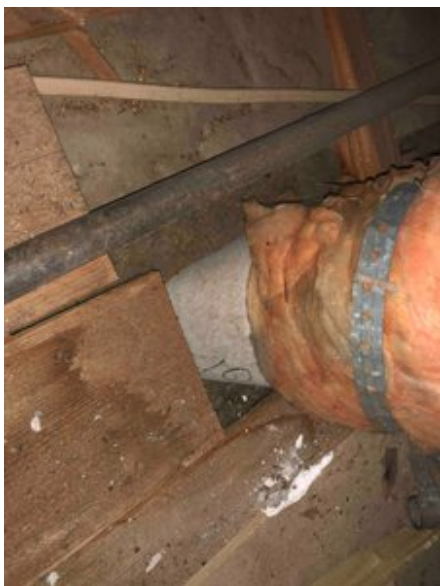
⌕ FIBERGLASS DUCTING

The boots of the fiberglass ducts include a known asbestos-containing paper seal where they join the registers. Although common sense may dictate that this asbestos-containing paper is not likely to have contaminated the system, asbestos has become such a litigious issue that we will not endorse it and encourage you to take whatever action you may deem appropriate.

The ducts are a semi-rigid compressed fiberglass type that can be easily damaged and do not spring back into shape. Also, their fibers could provoke an allergic response in people sensitive to this material.

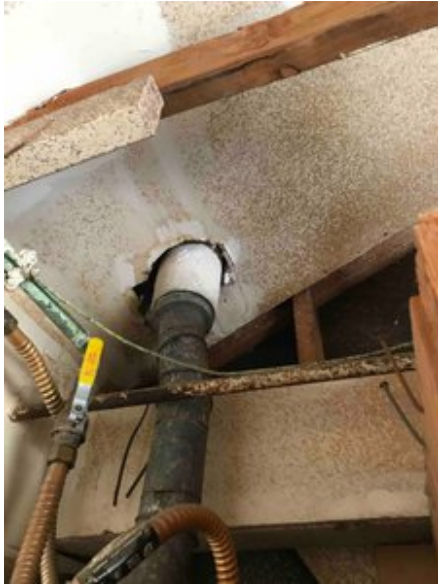
VENT PIPE & CAP

The heat vent includes a Transite pipe, which is comprised of a solid, cement-like material that is known to contain asbestos fibers. Admittedly, these fibers could not easily escape from within the material, but the majority of heat vents, and certainly those that pass through attics, are required to be double-walled, or Type-B. Inasmuch as an imperceptible crack in a single-walled vent pipe could result in a fire, we recommend that the Transite pipe be replaced with a modern double-walled type.

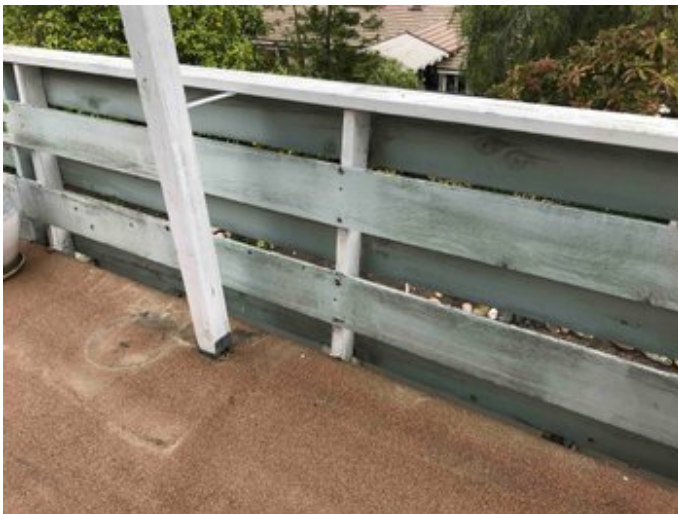
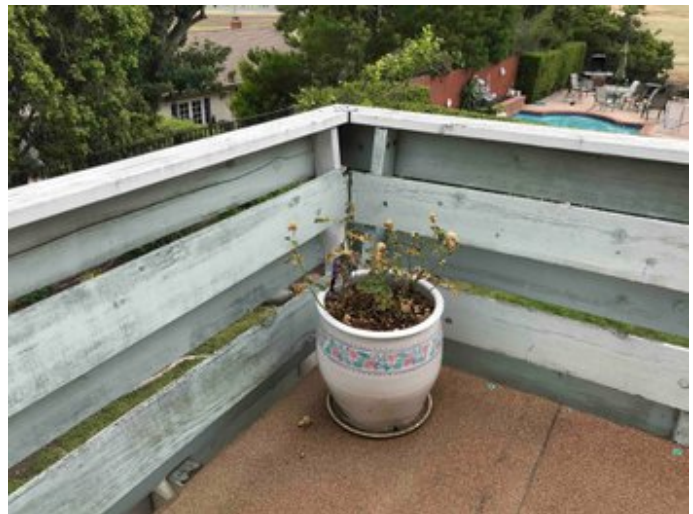
BALCONIES GUARDRAILS ETC

The balcony guardrail is climbable, and therefore not child-safe. If children occupy or visit this property appropriate precautions should be taken to make the area more secure.

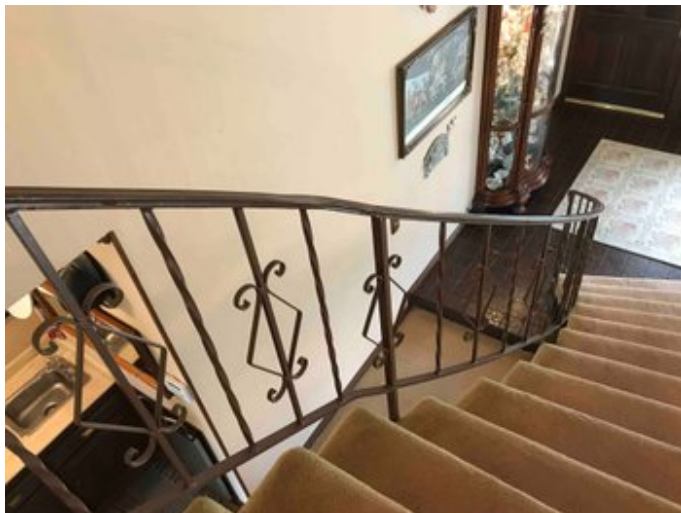
🔍 HANDRAILS & GUARDRAILS

The intermediate rails in the stair guardrails are more than four inches apart and are not child safe. Therefore, you may wish to add a protective barrier.

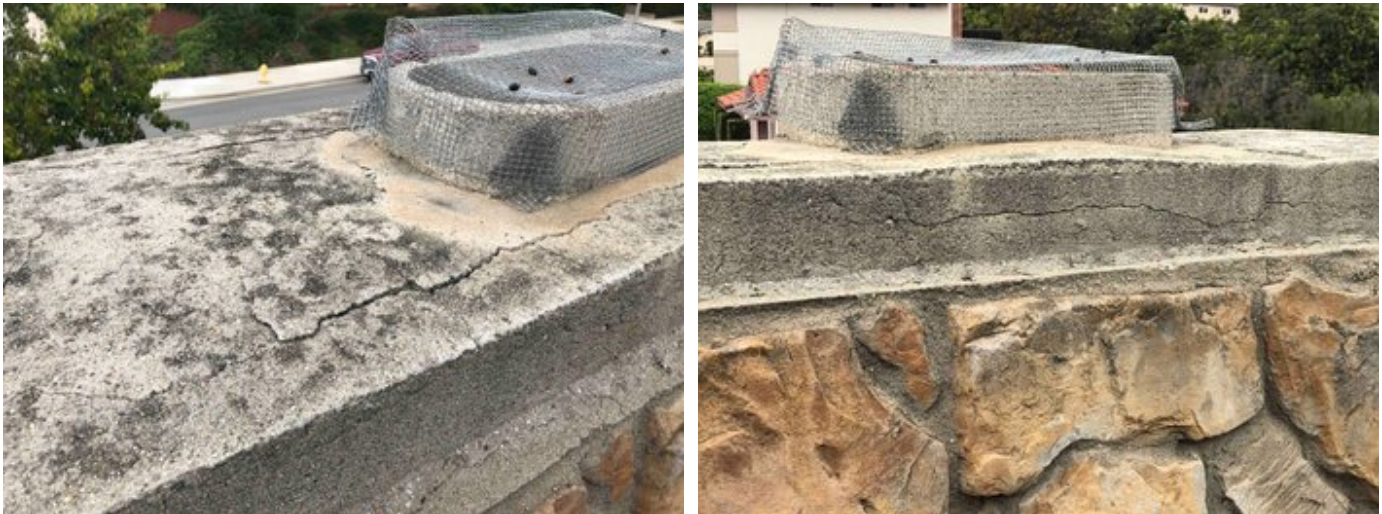
CROWN OR CHASE COVER

The crown, which is designed to seal the chimney wall and shed rainwater, is cracked and should be sealed.

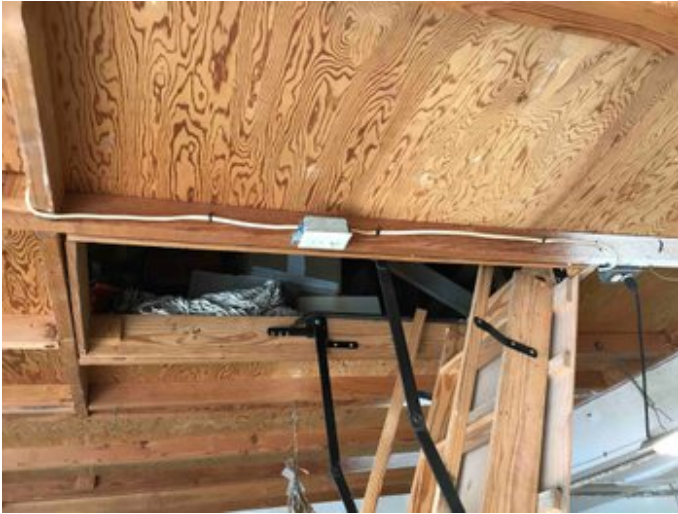
ELECTRICAL OBSERVATIONS

Generally, any wiring or conduit that has been installed exposed on the face of drywall or wall studs, or is less than six-feet off of the garage floor is considered to be subject to physical damage. Electrical standards require that NM type cable that has been installed in a manner that subjects to physical damage must be covered or otherwise shielded to prevent damage. Therefore, the NM cable in the garage should be serviced accordingly by a qualified contractor.

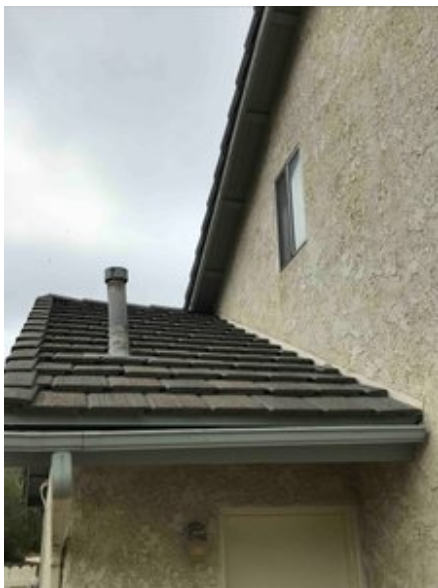
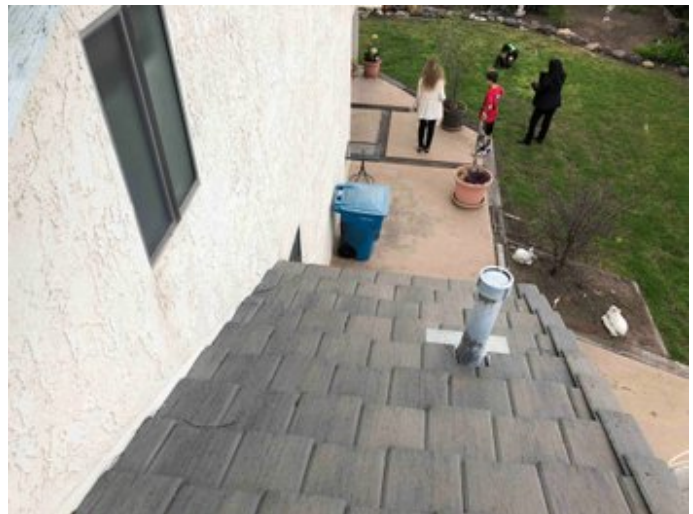
○ VENT PIPE & CAP

The termination for the water heater vent pipe is improper and too close to openable windows. This could result in carbon monoxide being introduced into the residence which is a significant health and safety hazard. Gas

appliance vents are required to terminate at least eight inches above the roof line where they are within eight feet of an openable window, or vertical wall. You may wish to get a second opinion by a qualified contractor for options on raising the vent to an acceptable height, but in any event, it is recommended that appropriate measures are taken to eliminate the potential for carbon monoxide to enter the residence from this vent.

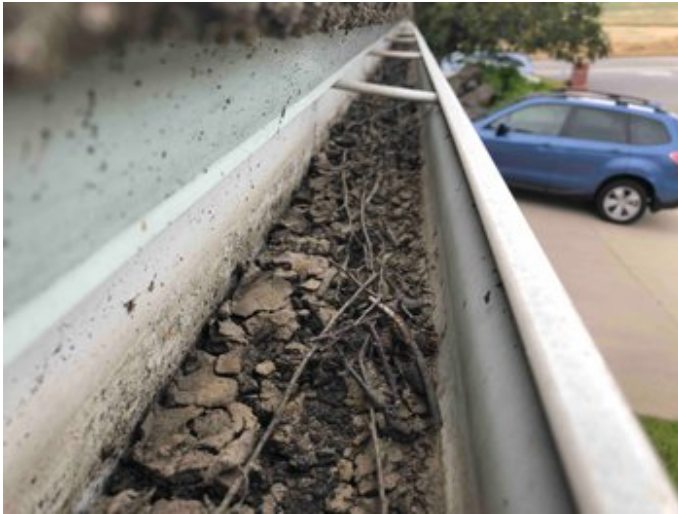
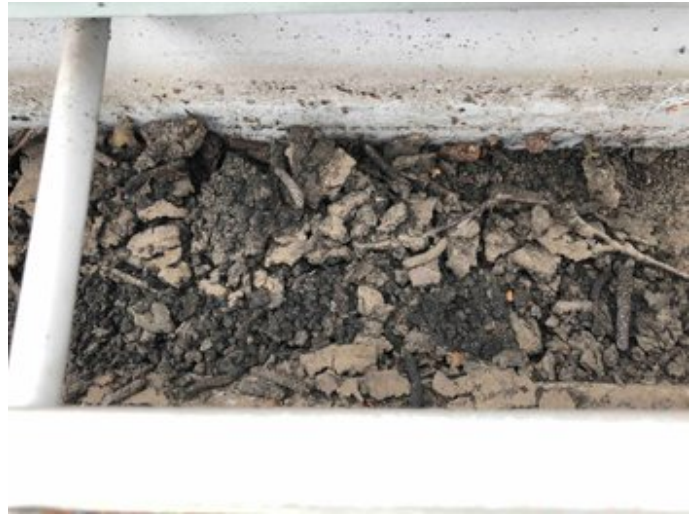
GUTTERS

The roof gutters need to be cleaned and serviced in order to drain properly.

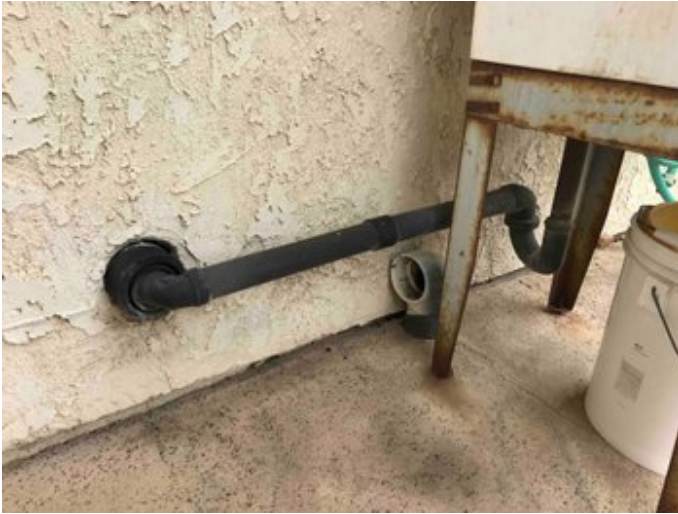
DRAIN WASTE & VENT PIPES

A sink drain has been tied into a clean out, which is improper. All connections are required to be made with approved fittings and this should be corrected by a qualified plumber.

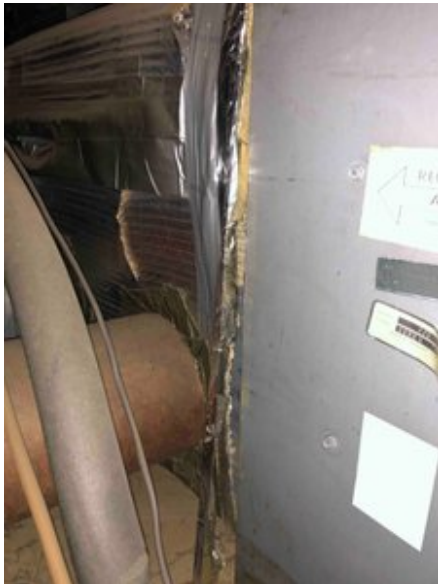
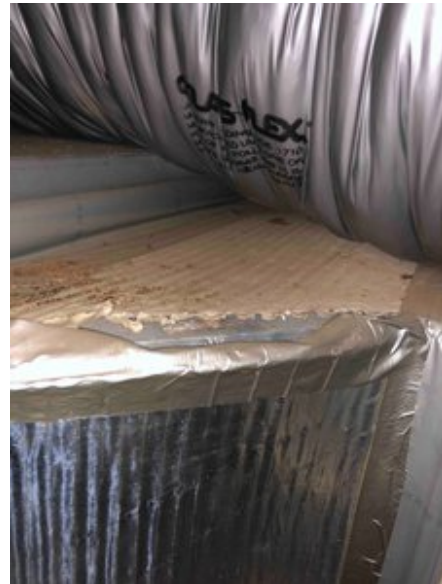
❖ COMMON OBSERVATIONS

The asbestos-containing material (ACM) used to insulate the evaporator coil are in friable condition, which means they present a health hazard in their current condition. This material should be removed by a qualified contractor, and disposed of in accordance with local and federal laws.

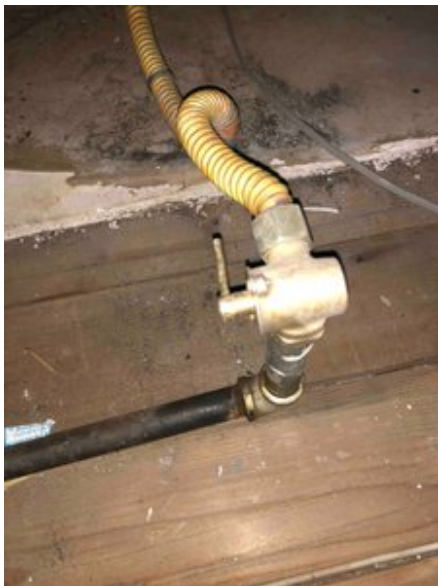
⬢ GAS VALVE & CONNECTOR

There is an odor of gas at the appliance connector for the furnace in the attic, which should be serviced as soon as possible by a qualified contractor.

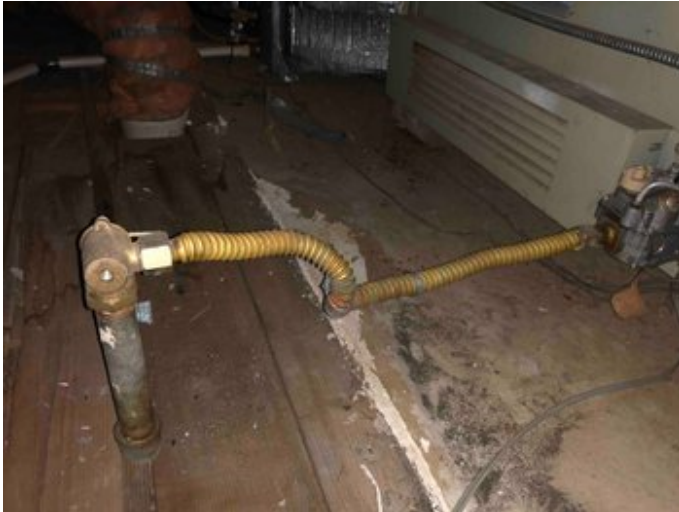
⬢ GAS VALVE & CONNECTOR

The gas line includes a brass appliance connector. Brass connectors have been recalled by their manufacturers and are no longer allowed for use in gas supply systems. Additionally, the utility company will discontinue service to the residence if they become aware that brass connectors are in use. The connector should be replaced with a flexible steel connector by a qualified plumber.

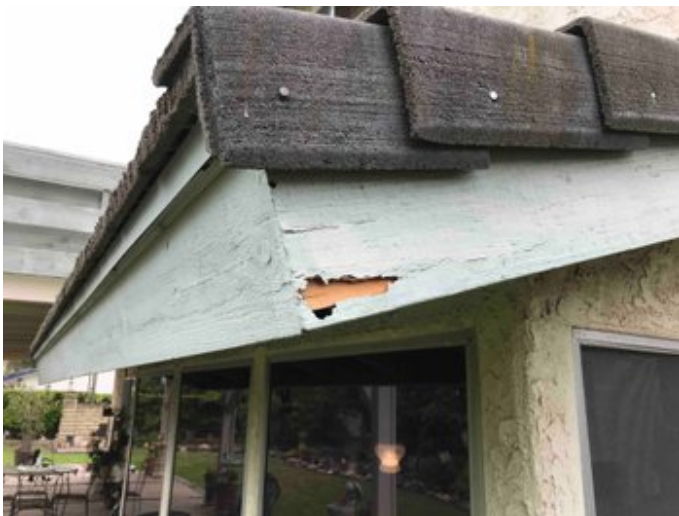
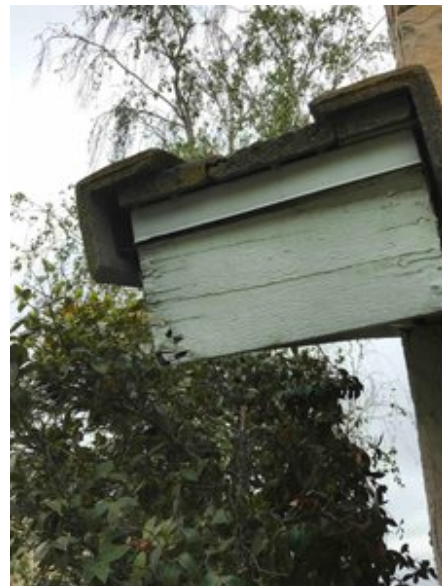
◊ FASCIA & TRIM

There is damage to the wood trim that should be evaluated for service by a qualified termite inspector.

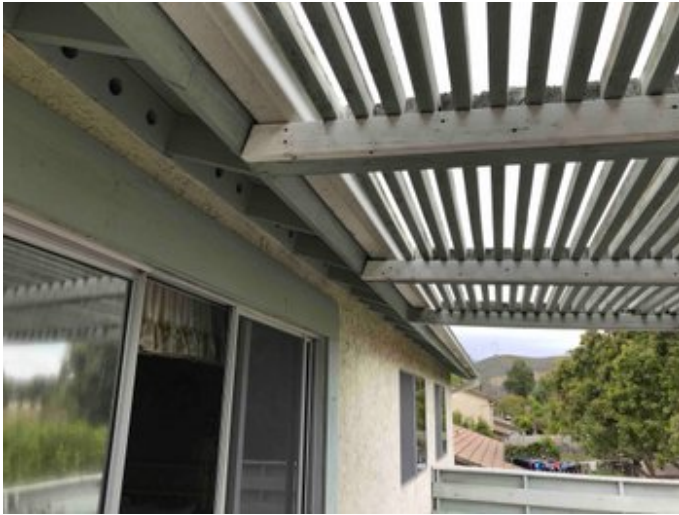
⬢ PATIO COVERS OR GAZEBOS

The patio cover has been attached directly to a fascia board, which has no structural value. There are no indications that this fascia board has been adequately secured to the structure in order to support the patio cover. Generally, a ledger board is bolted directly to the structure for adequate support. You should have the patio cover evaluated by a qualified contractor, and serviced to ensure that an adequate attachment has been established.

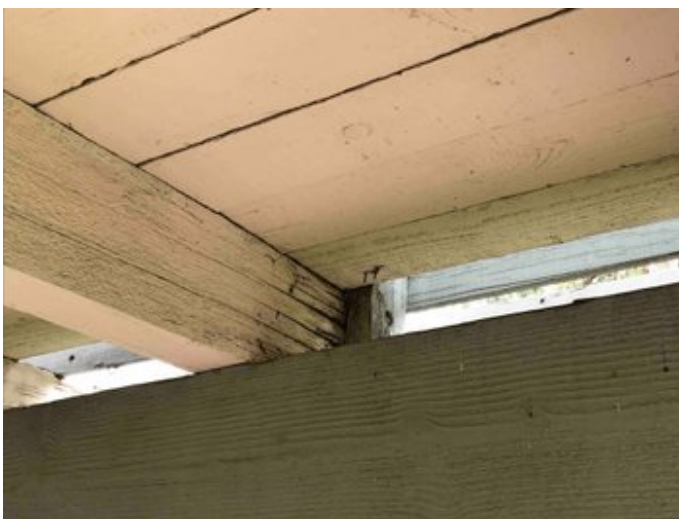
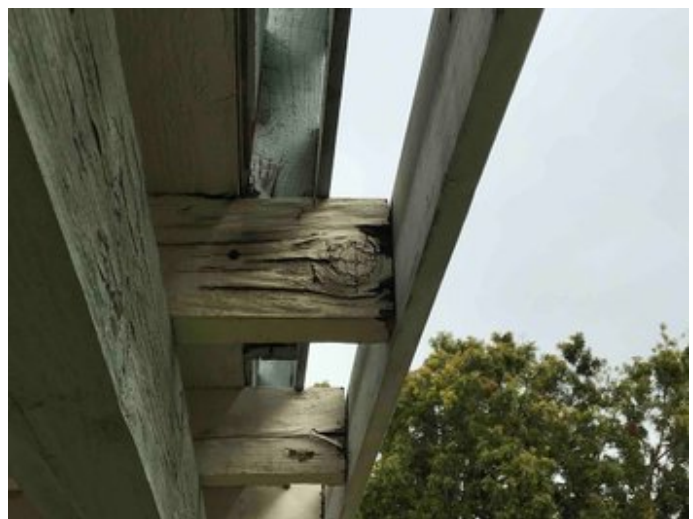
⬢ BALCONIES GUARDRAILS ETC

There is damage to the beams of the balcony that should be evaluated by a qualified termite inspector.

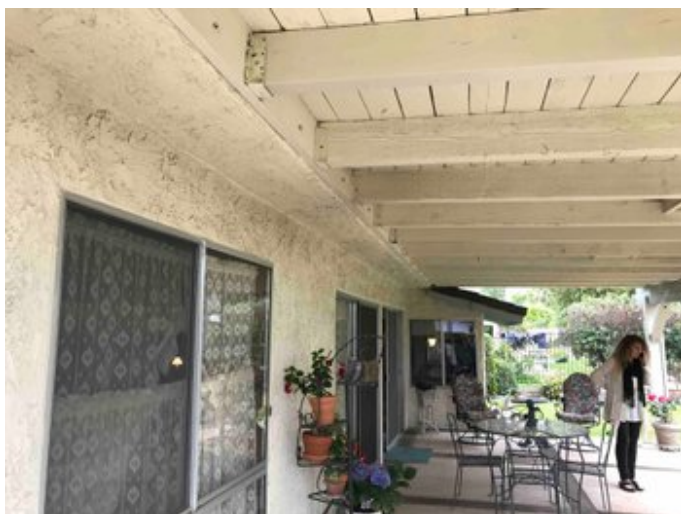
BALCONIES GUARDRAILS ETC

The balcony has been attached to and is being supported by the cantilever floor joists of the residence. This is generally not allowed by building standards, and is an indication that appropriate building permits were not obtained for the installation. We do not endorse the installation of the balcony and recommend that it be removed. You may wish to seek a second opinion before acting upon this recommendation.

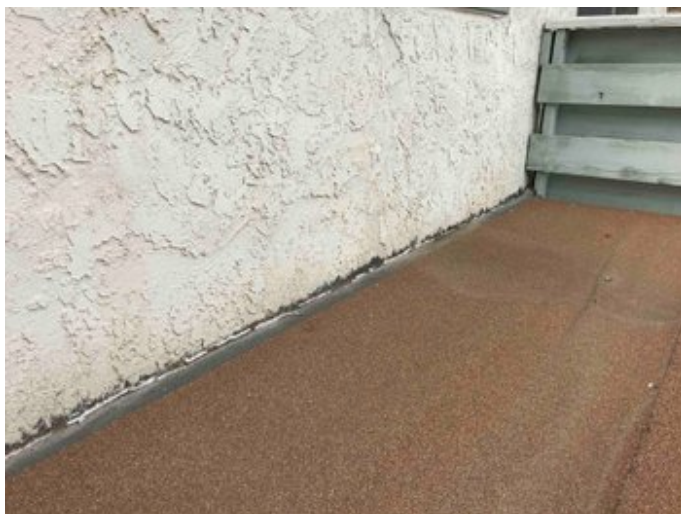
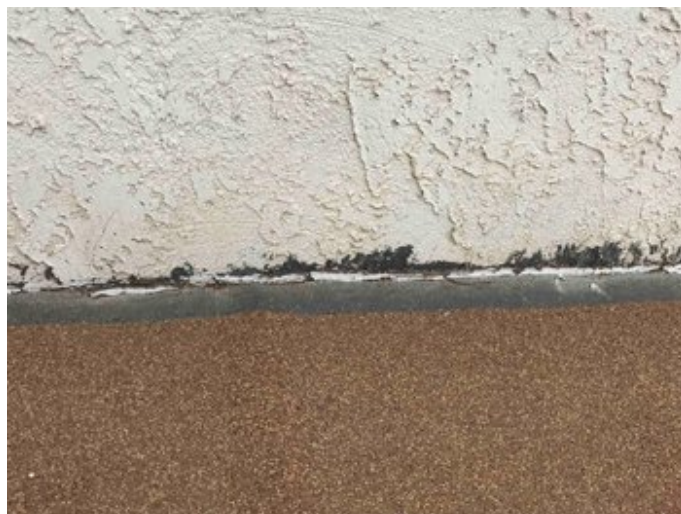
BALCONIES GUARDRAILS ETC

The ledger for the balcony has been attached to the structure with lag-bolts, which unavoidably pierce the waterproof membrane of the exterior siding. The bolts may have been installed with a sealant to reduce the potential for leaks, but there is no visible flashing above the ledger attachment, and this will remain a potential point for moisture intrusion to the interior of the residence. For this reason, we recommend that a flashing be

installed beneath the stucco above the ledger-board by a qualified contractor to reduce or eliminate the potential for moisture intrusion.
